RECOMMENDATION TO AVOID SYNTHETIC OR COTTON FIBER CONTACT WITH IMPELLA® HEART PUMP

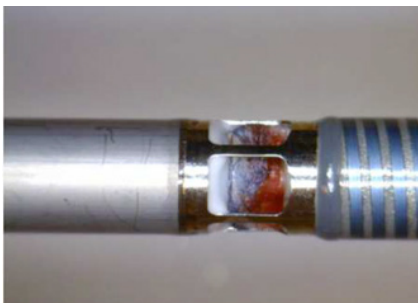
Analysis of cases where lower than expected flows were reported has shown clot formation along the internal blood flow path can occur. Examination of the clot composition showed that clots were formed around a matrix comprised of blue or white fibers typically found in sterile towels and drapes.

Clot and fibers lodged in pump

- DO NOT ATTEMPT TO RINSE AND REINSERT THE DEVICE.
- Keep the Impella® Heart Pump in its packaging tray until just before insertion.
- To control blood splatter when inserting the Impella® Heart Pump through the introducer, hold the surgical towel or 4 x 4 gauze pad away from the inflow and outflow windows.
