RECOMMENDATIONS FOR PATIENTS WITH MEDTRONIC COREVALVE™ OR EVOLUT™ R TRANSCATHETER AORTIC VALVES REQUIRING IMPLANT OF IMPELLA 2.5® AND IMPELLA CP®

Important Considerations for Impella Use in Patients with Medtronic CoreValve or Evolut R Transcatheter Aortic Valve Prostheses

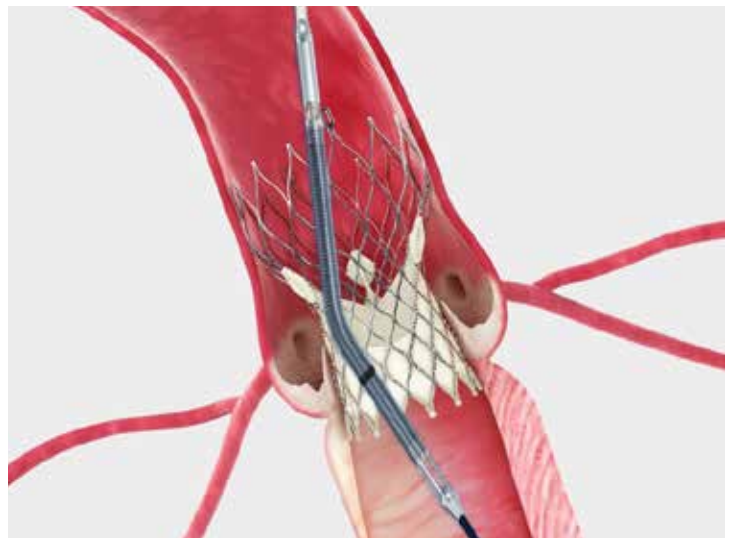
There is a potential risk for unintentional interaction of the Impella motor housing with the distal stent of a Medtronic CoreValve™ Evolut™ R transcatheter aortic valves resulting in destruction of the impeller blades. This has resulted in low flow from the damaged Impella system.

The outflow struts of the CoreValve or Evolut R nitinol frame can enter the outlet opening of Impella and damage the impeller. This interaction while running the pump can result in fracture of the impeller material. **See figure 1 to the right.** Although no events have been identified, systemic embolization of the fractured impeller material is a possibility.

Figure 1: Illustration of a Medtronic CoreValve Transcatheter Aortic Valve and Interaction of Impella® Motor Housing

Clinicians are cautioned to position the Impella system carefully in patients with the Medtronic CoreValve or Evolut R transcatheter aortic valves prostheses and to be aware of this potential interaction. In this situation, clinicians should **avoid repositioning while the device is running and should turn the device to P0 during repositioning or any movement that could bring the outlet windows into proximity to the valve stent structures.**
